Technical Report REMR-CS-60
September 1998

Repair, Evaluation, Maintenance, and Rehabilitation Research Program

Performance Criteria for Concrete Repair Materials, Phase II Field Studies

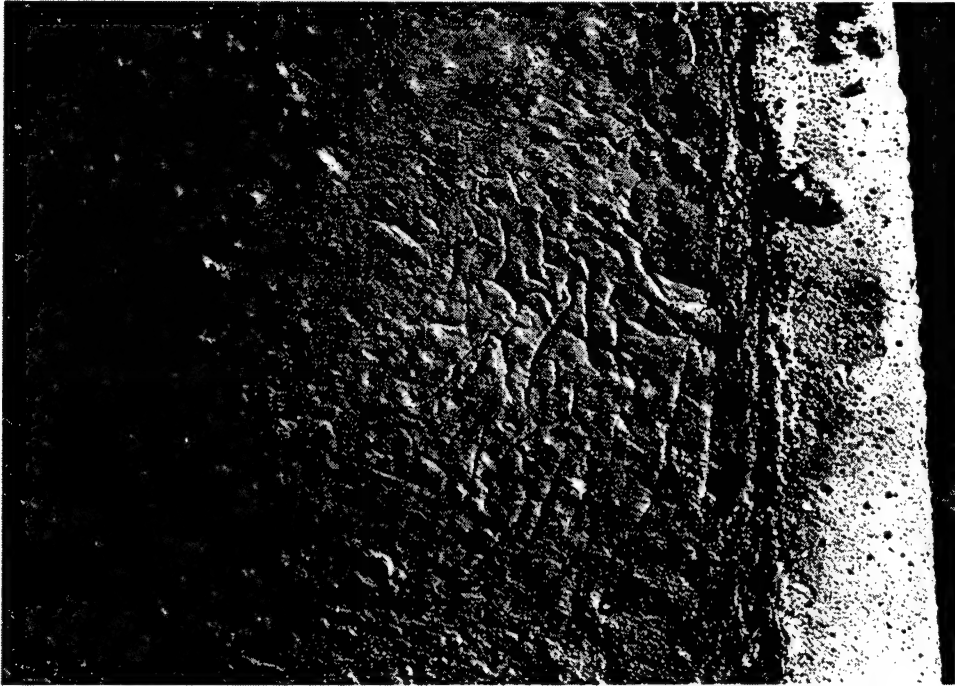
Figure 14. Very cohesive material (No. 10), sticky, difficult to finish (Florida)
